29-632

Saab steering wheel control interface

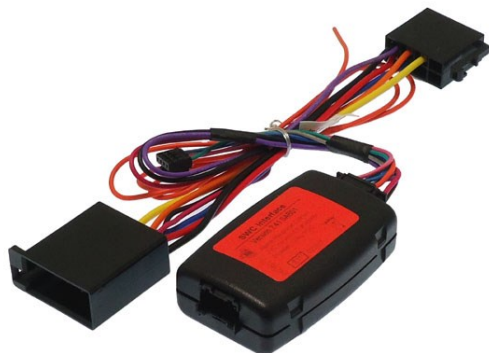
Supported functions

Volume up
Volume down
Seek/track up
Seek/track down
Source

Connect the head unit specific patch lead to the interface first. If using a universal patch lead, check it is setup correctly. Refer to the diagrams overleaf to check the patch lead is correct.

Connect the ISO connectors and patch lead to the new head unit.

Identify the steering wheel control signal wire under the steering column. This will be a wire that rests at 4.5V on a 2 or 3 way connector. This voltage will fluctuate when buttons are pressed on the steering wheel.

Connect the loose orange wire from the interface to this steering control wire under the steering column.

Connect the 29-632 harness to the vehicle harness.

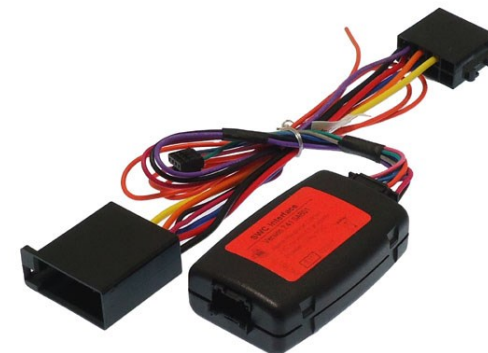
Supported functions

Volume up
Volume down
Seek/track up
Seek/track down
Source

Connect the head unit specific patch lead to the interface first. If using a universal patch lead, check it is setup correctly. Refer to the diagrams overleaf to check the patch lead is correct.

Connect the ISO connectors and patch lead to the new head unit.

Identify the steering wheel control signal wire under the steering column. This will be a wire that rests at 4.5V on a 2 or 3 way connector. This voltage will fluctuate when buttons are pressed on the steering wheel.

Connect the loose orange wire from the interface to this steering control wire under the steering column.

Connect the 29-632 harness to the vehicle harness.

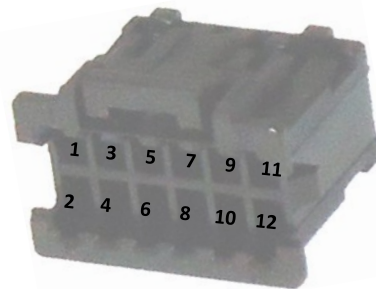
Patch lead wiring configurations

29-000 Self learning units

Single wires pins 1 and 2
No loops

29-001 Alpine

3.5 jack pins 1, 2 and 3
Loop pins 9 + 10

29-003 Clarion

3.5 jack pins 2 and 3
Loops 5 + 6 and 11 + 12

29-004 JVC

Single wire pin 3, 3.5 jack
pins 2 and 3
Loop pins 11 + 12

29-005 Kenwood

Single wire pin 3
Loop pins 7 + 8

29-007 Pioneer

3.5 jack pins 1, 2 and 3
Loop 5 + 6 (some leads also
have 7+8 looped, both are the same)

29-008 Sony

3.5 jack pins 1, 2 and 3
Loops 7 + 8 and 9 + 10

29-011 Zenec

Single wire pin 3
Loops 5 + 6, 7 + 8
and 9 + 10

29-012 Philips

Single wire pin 3
Loops 5 + 6, 9 + 10
and 11 + 12

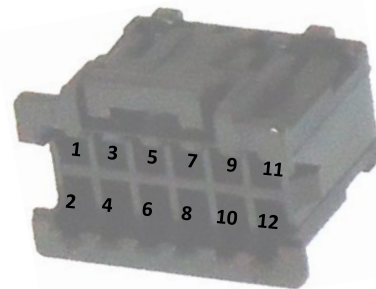
Patch lead wiring configurations

29-000 Self learning units

Single wires pins 1 and 2
No loops

29-001 Alpine

3.5 jack pins 1, 2 and 3
Loop pins 9 + 10

29-003 Clarion

3.5 jack pins 2 and 3
Loops 5 + 6 and 11 + 12

29-004 JVC

Single wire pin 3, 3.5 jack
pins 2 and 3
Loop pins 11 + 12

29-005 Kenwood

Single wire pin 3
Loop pins 7 + 8

29-007 Pioneer

3.5 jack pins 1, 2 and 3
Loop 5 + 6 (some leads also
have 7+8 looped, both are the same)

29-008 Sony

3.5 jack pins 1, 2 and 3
Loops 7 + 8 and 9 + 10

29-011 Zenec

Single wire pin 3
Loops 5 + 6, 7 + 8
and 9 + 10

29-012 Philips

Single wire pin 3
Loops 5 + 6, 9 + 10
and 11 + 12
